Project: Summary of Field Oversight/Documentation Services
Removal/Replacement of SWM Piping
SWM Basin behind Hickory Street within the OAKS HOA
N. Londonderry Township, Lebanon County, Pennsylvania

The ALW Group, LLC (ALW) has prepared summary letter report documenting field oversight in support of the replacement of damaged SWM piping at the above-referenced site. The following paragraphs outline background information pertaining to the project, outline of the scope of services, and the findings/results of the SWM removal and replacement work performed by Starnier Excavating LLC (herein referenced as “Contractor”). Our services were provided in general accordance with the executed ALW Proposal, dated January 22, 2024.

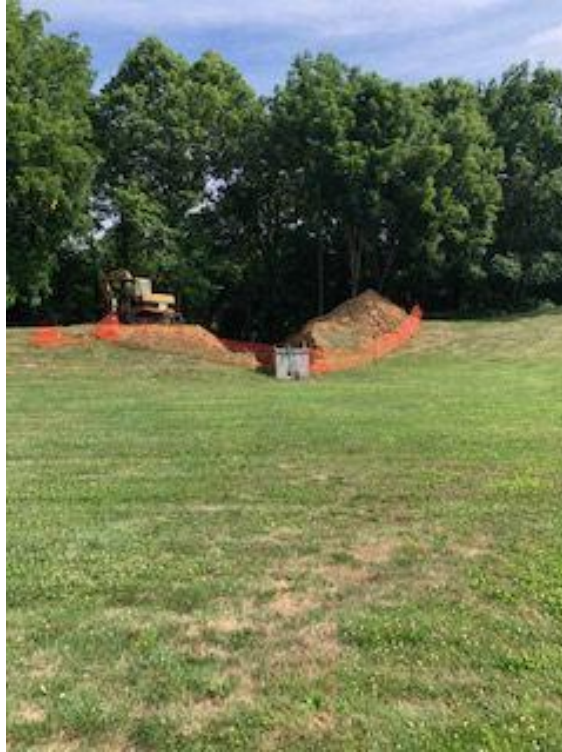
In January of 2024, the Oaks HOA contracted ALW to visit an area of concern (AOC) associated with a stormwater management (SWM) basin situated behind homes along Hickory Street. Our site visit included members of the HOA and a representative of the Contractor. The SWM basin collects runoff from several areas along Hickory Street. Stormwater conveyed to this basin is eventually carried and discharged to a nearby wooded area of lower elevation. The basin includes a release structure (15-inch opening) and a 24-inch PVC outlet pipe which carries storm water out of the basin. The historic AOC encompasses the outlet structure and underground piping, where numerous sinkholes and/or settlement features have occurred.

- A soil collapse or closed depression had formed immediately behind the outlet structure located on the downgradient side of the basin. The area of the depression measured roughly 10 feet by four feet and was situated above the outlet pipe or adjacent to it.

**Photograph No. 1 – View across the SWM basin and the outlet structure at AOC.
Photograph facing north**

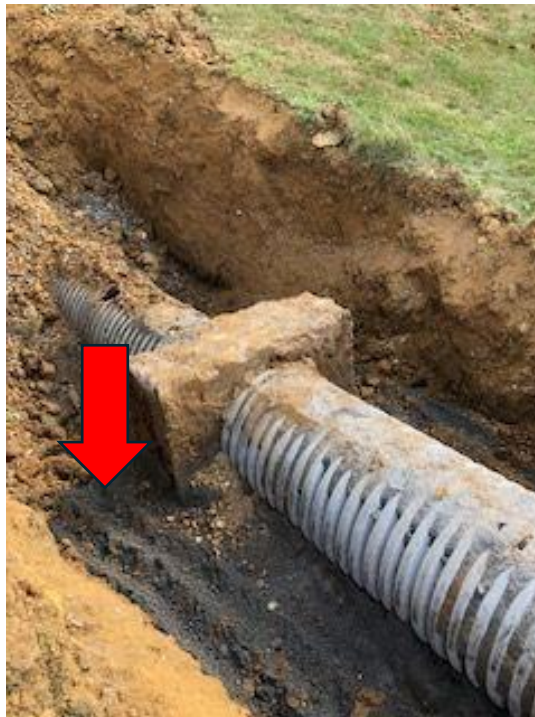
- The first section of 24-inch pipe behind the outlet structure included a poured-in-place concrete anti-seepage collar.
- The section of pipe between the outlet structure and anti-seep collar was resting on a thin (about two-inches thick) poured, reinforced concrete pad.

Outlet Structure
Is About Here

Photograph No. 2 – View of the initial excavation exposing the existing pipe and anti-seep collar. The edge of the section of the pipe sitting over the concrete pad is noted with arrow.

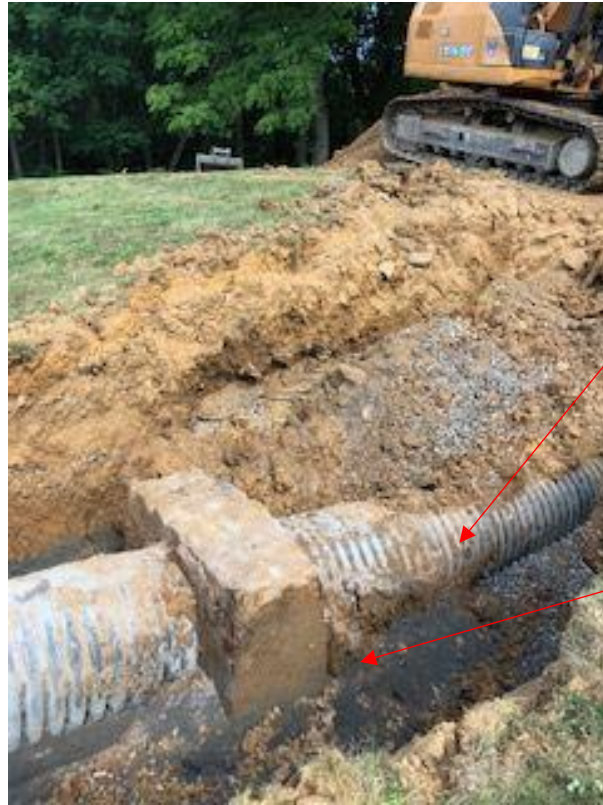
- The concrete pad ended at about the anti-seep collar location (approximately 15-20 feet behind the outlet structure). Beyond this point, the subgrade beneath the pipe included a soil-rock mixture. The subgrade soil and rock immediately beneath the existing pipe was wet throughout this area. The next section of pipe (beyond the anti-seep collar) was obviously damaged and cracked at several locations. The damaged pipe was noted in the immediate area of underlying saturated soils.

2. There was clear and obvious damage to the former SWM pipe. The damaged section of pipe was located in the immediate vicinity of multiple past repairs and coincided with the edge of an encountered buried concrete pad. Wet/soft conditions were noted immediately underlying the section of pipe that was damaged and along the edge of the concrete pad. It is difficult to determine what caused the damaged pipe and whether the leaking pipe was the root source for the eventual sinkholes/ground subsidence beneath and around the SWM pipe. Regardless, the leaking pipe certainly would have contributed to the ongoing weakened subsurface conditions over a period of time the eventually lead to additional failure(s).

Leaky section of Pipe

Edge of Concrete Pad

Photograph No. 3 – Additional view of exposed pipe facing northwest. Arrow notes the section of pipe that was obviously damaged and leaking.

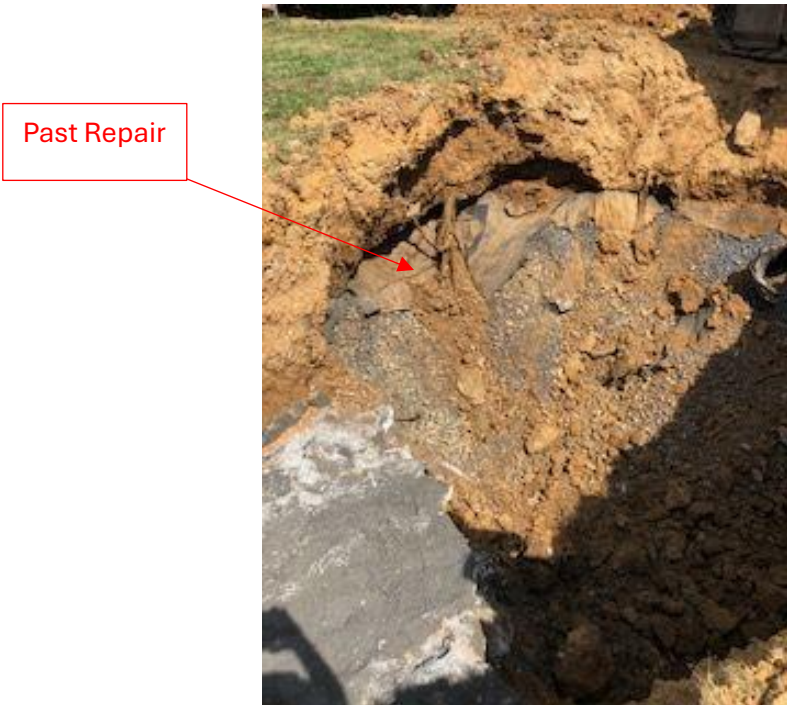
- Along the sidewall (western side), a previous “rock filter” type repair was encountered. The rock filter was noted just a few feet beneath the existing ground surface and extended beneath the pipe invert elevation. The rock filter consisted of several geotextile fabrics and various sized aggregate including some cobble and boulder sized material.

Past Repair

Photograph No. 4 – View of excavation after removal of pipe, anti-seep collar and portion of damaged concrete pad. Note past repair along sidewall and extending beneath pipe.

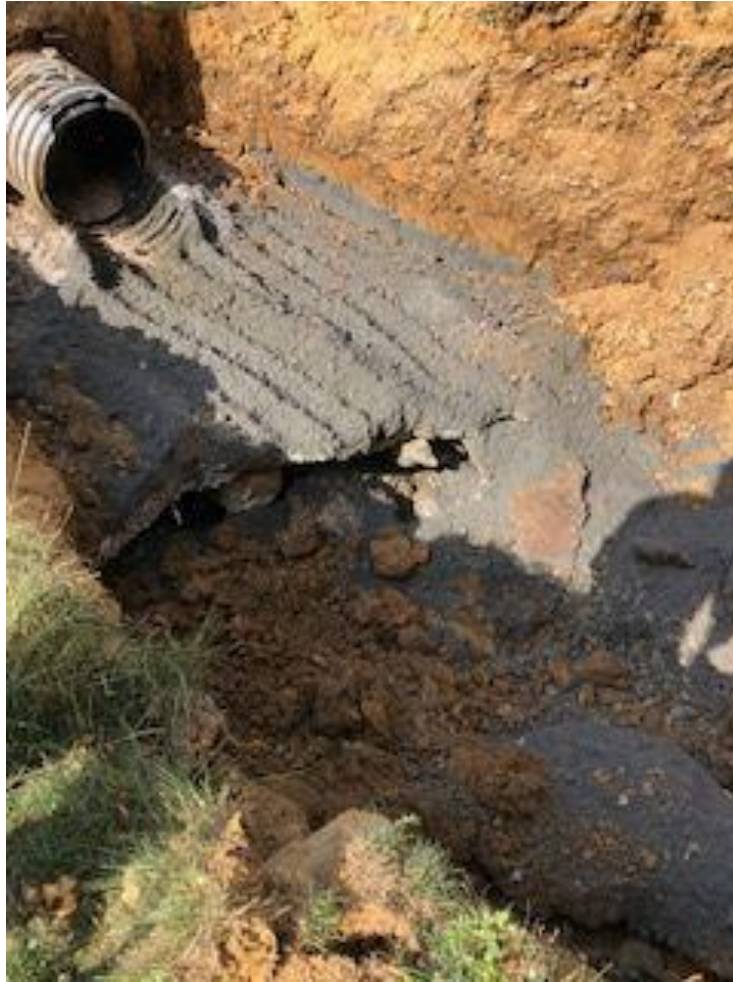
- The concrete pad was poured over top of several feet of placed boulder-sized rocks which were stacked.
- The concrete pad was poured over top of several feet of placed boulder-sized rocks which were stacked. The stacked rocks appeared to be stable but did not include finer or smaller aggregate; therefore, leaving numerous void spaces between the rocks. The poured concrete pad and underlying placed boulders appear to be part of past repair efforts.

Photograph No. 5 – View behind outlet structure after pipe, anti-seep collar and portion of pad was removed. Note the void space and large rock beneath the edge of the concrete pad.

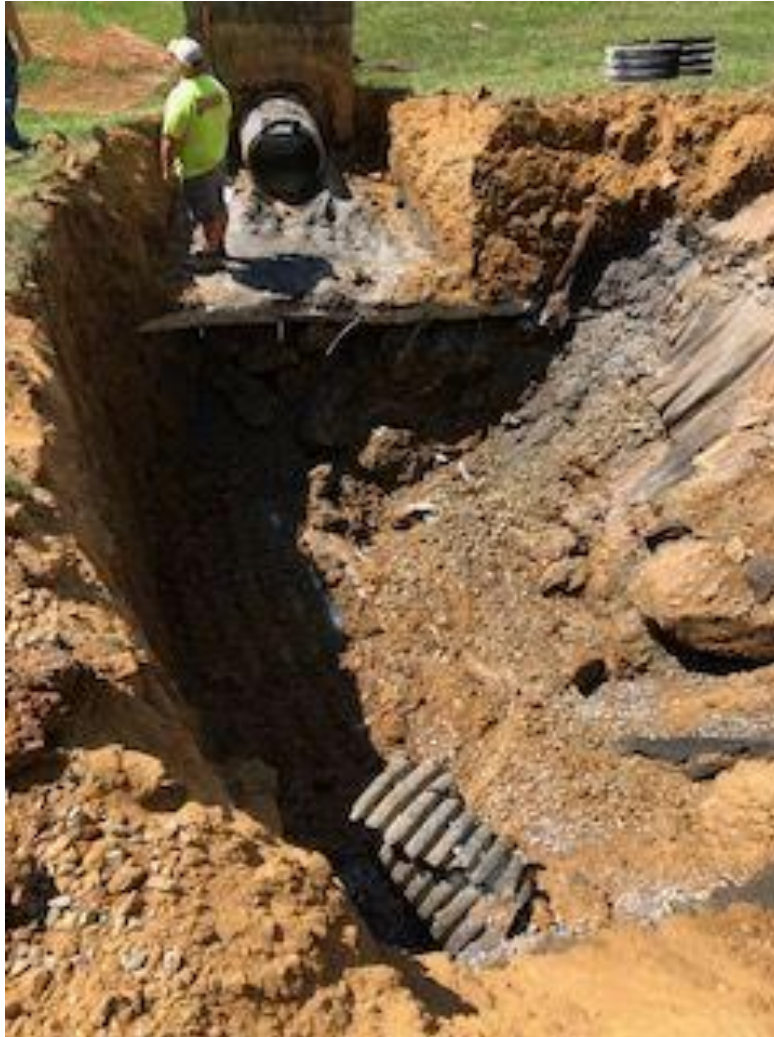
Photograph No. 6 – View of excavation as cleanup of soft/wet subgrade continued.

Based on our initial observations during the excavation and demolition activities, ALW directed the Contractor to remove the anti-seep collar and a portion of the degraded concrete pad along with soft, loose and/or wet soil materials beneath the bottom of the pipe beyond the concrete pad. The excavation of these materials also extended along the sidewalls in order to remove additional loose materials and slope back the excavation. The excavation extended about 5 feet beneath the bottom of the existing pipe elevation. At this point, the Contractor began to encounter what appeared to be stable soil conditions and some competent bedrock surfaces. The visible bedrock surfaces did not reveal any obvious openings/fractures.

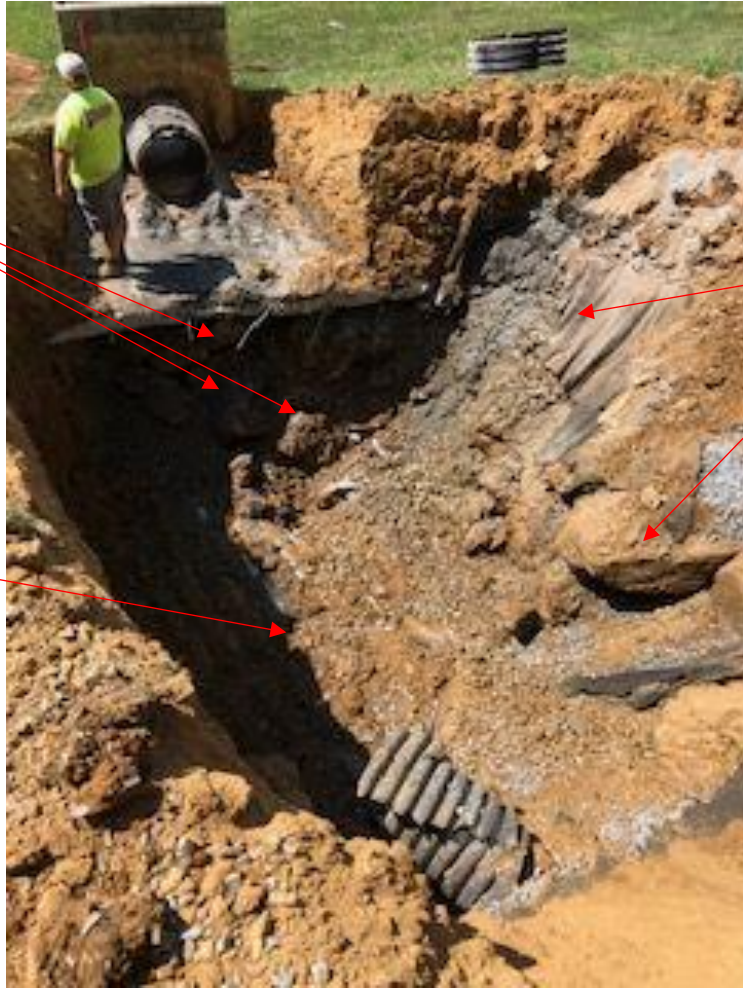
Stacked Rock Boulders
Beneath Pad

Past Repairs

Apparent Top of
Bedrock Here

Photograph No. 7 – Additional view behind outlet structure. Note stacked rocks beneath past concrete pad repair and separate past sidewall repair (rock filter).

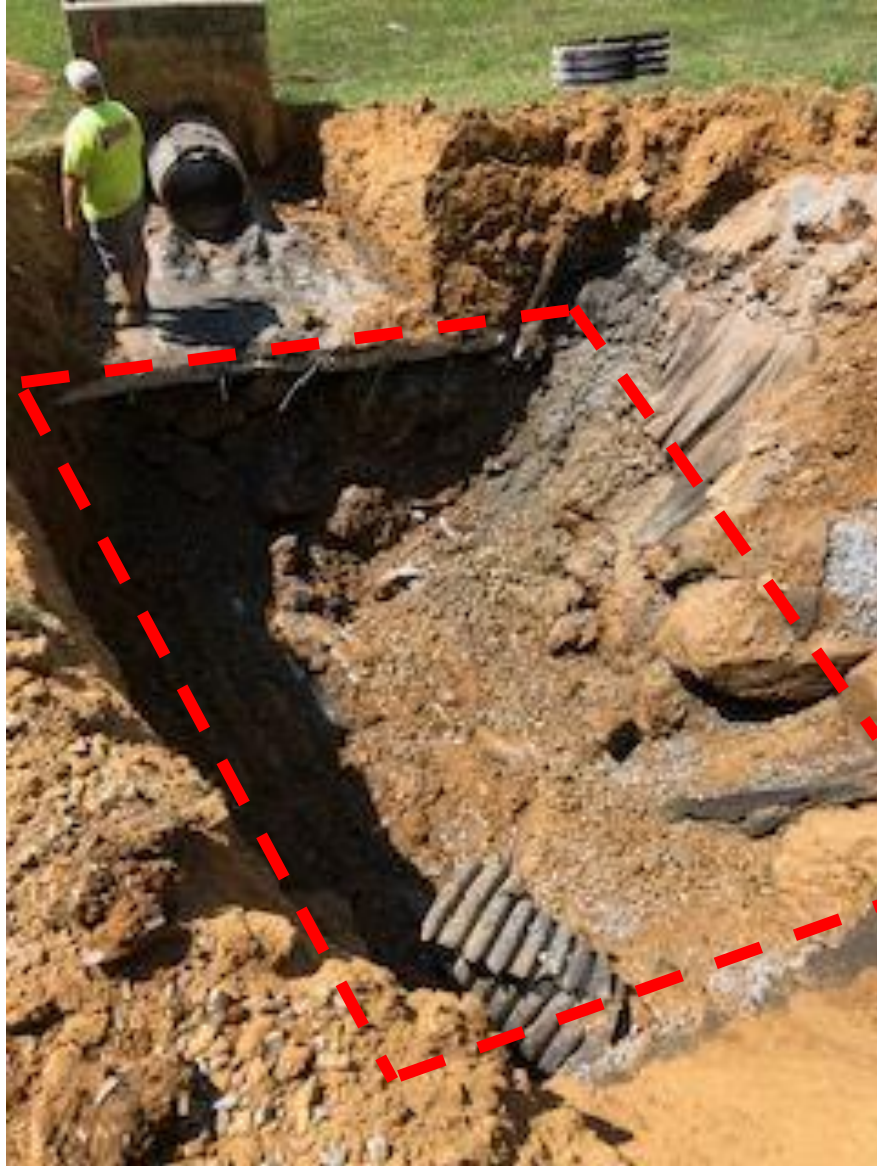
In summary, the excavated and removed pipe, rock and soft/wet soils on this date appeared to encompass the majority of past repairs and the most recently observed sinkhole/subsidence. Some of the past repairs were observed to continue laterally away from the pipe location (into the sidewall) and deeper into the subsurface (beneath the remainder of the concrete pad)

Photograph No. 8 – Additional view of first section of pipe removal and excavation of past repair and AOC areas. The area designated with RED represents a approximate picture of the area to be backfilled using low-strength cement flowable fill.

As such, we recommended that the excavations performed on this date be backfilled prior to continuation of the remaining 50 percent of the pipe excavation/removal. Excavations were subsequently backfilled with a flowable fill mixture of low-strength sand, cement and water. Approximately 40 cubic yards of 125-150 psi flowable fill was placed within the excavations on this date. The backfilled zone was subjected to a vibrator during placement and was terminated about 6 inches to 1 foot beneath the new pipe invert elevation. Upon completion of the flowable fill placement, the area was allowed to rest or cure before returning the site to continue work activities on July 9, 2024.

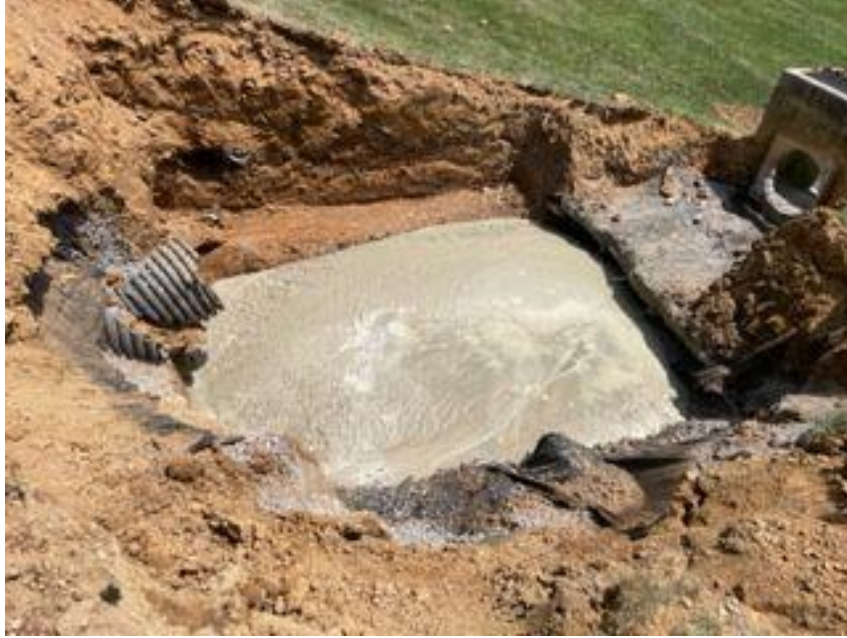
Photograph No. 9 – View of Photograph No. 8 area after backfilling with flowable fill.

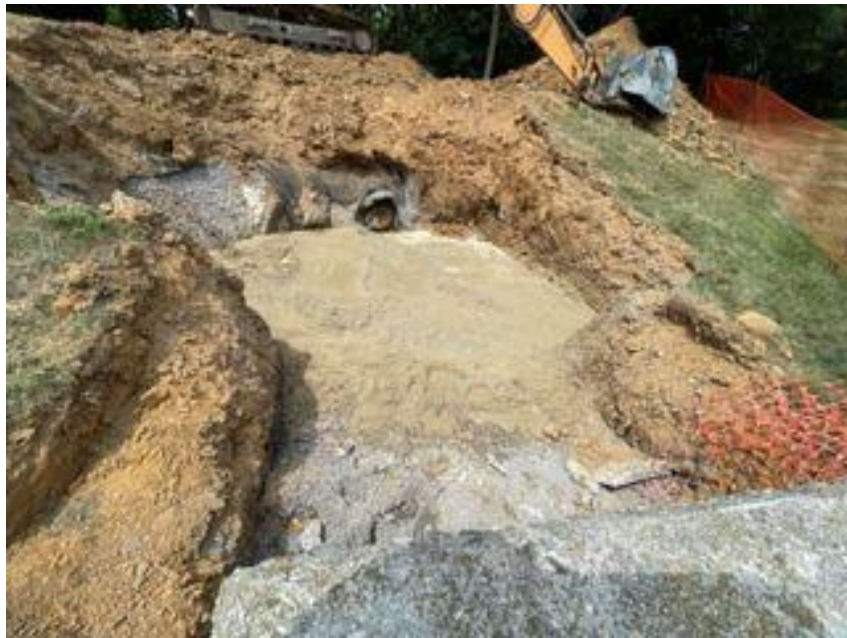
Photograph No. 10 – Additional view of flowable fill on July 8, 2024, facing north.

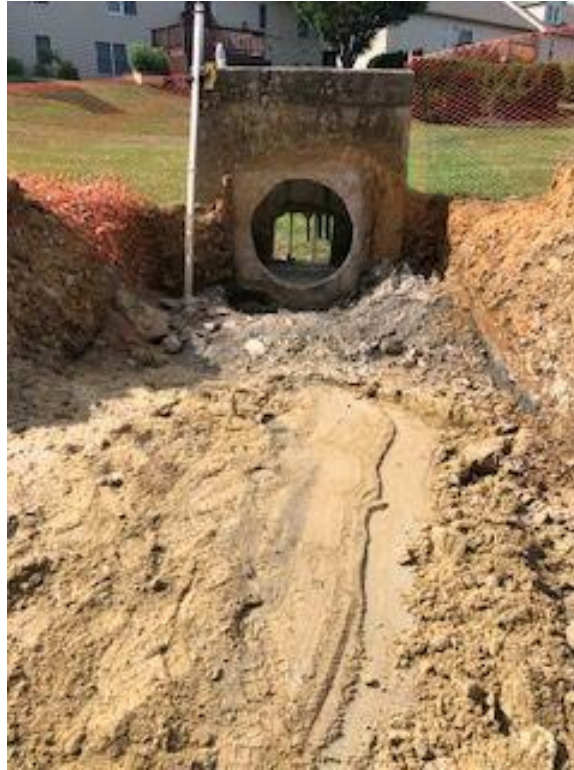
Upon arrival, the flowable fill appeared stable and unyielding. No discernible areas of settlement in the flowable fill or surrounding exposed soil subgrade were noted. The contractor proceeded with excavation and removal of the remaining 30 feet or thereabout of existing pipe.

Photograph No. 11 – Photograph on July 9, 2024 after flowable fill placement of July 8, 2024

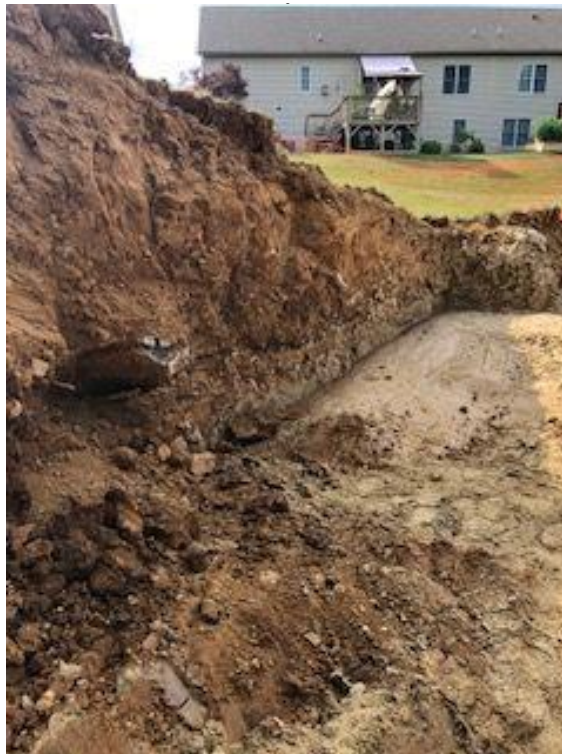
Photograph No. 12 – View of flowable fill along eastern sidewall, facing south

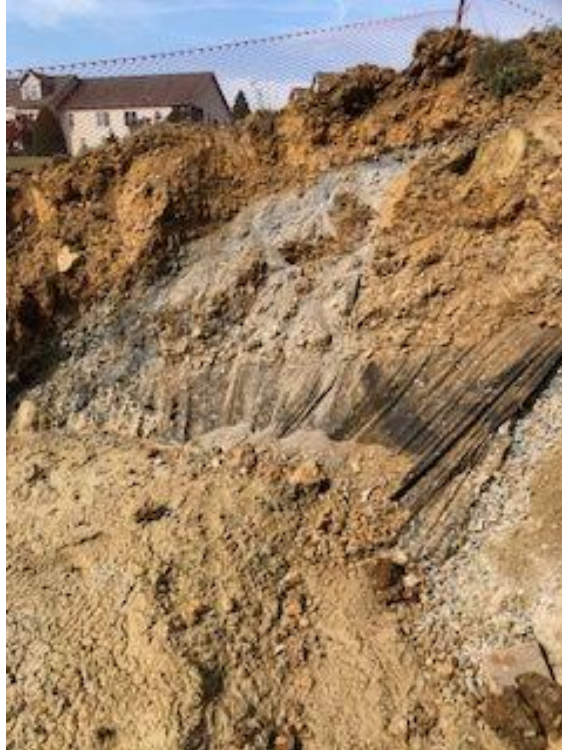
Photograph No. 13 – Flowable fill placement along western sidewall and past repair area, facing southwest.

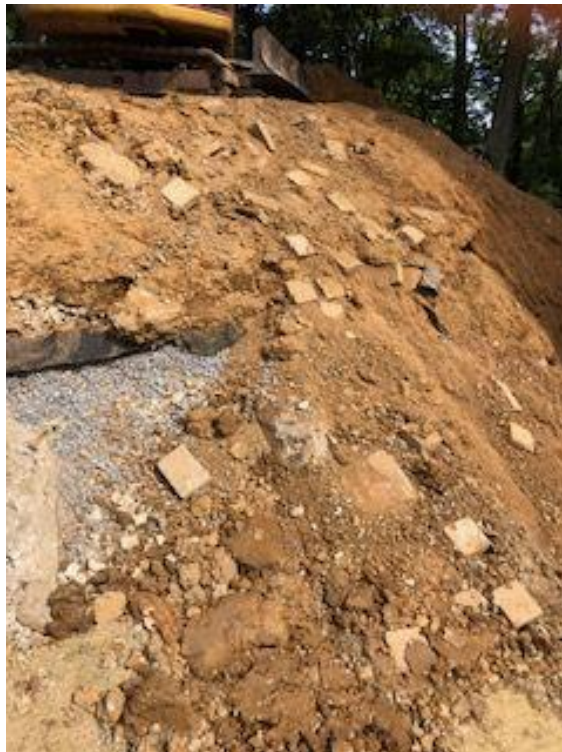
Photograph No. 14 – View of evidence of past repairs and materials used, along sidewall

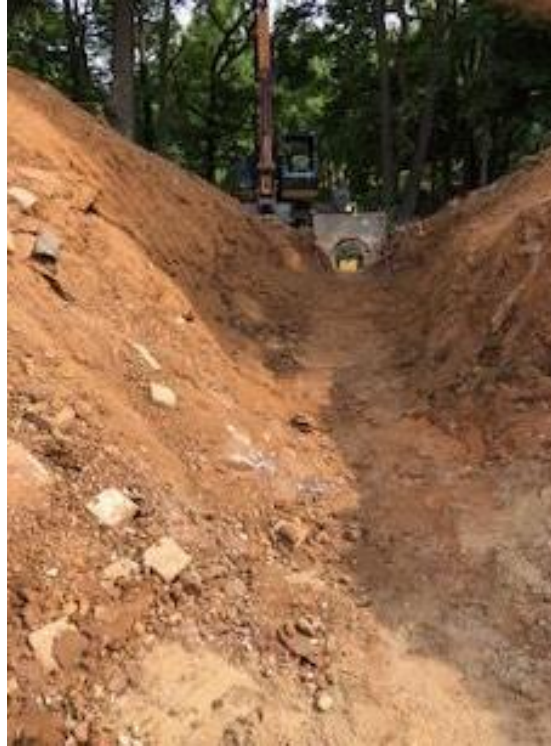
Throughout the removal and excavation process, the subgrade conditions along the bottom and sidewalls were observed and probed for any anomalies. No instability, soft/wet conditions or conditions potentially indicative of sinkholes were observed. The soils generally appeared to consist of natural silt and clay soils. Utilizing a vibratory plate attachment, the Contractor compacted the existing subgrade and sidewalls along and beneath the pipe section. In addition, the plate compactor was applied throughout the backfilled zone from the previous day.

Photograph No. 15 – Remaining alignment after completion of existing pipe removal and subgrade preparation on July 9, 2024. Photo facing end wall.

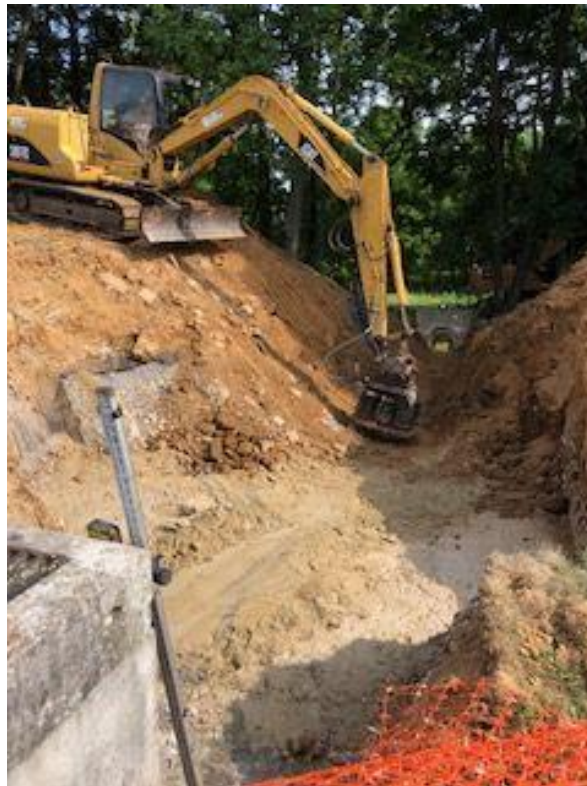
Photograph No. 16 – Contractor compacting subgrade

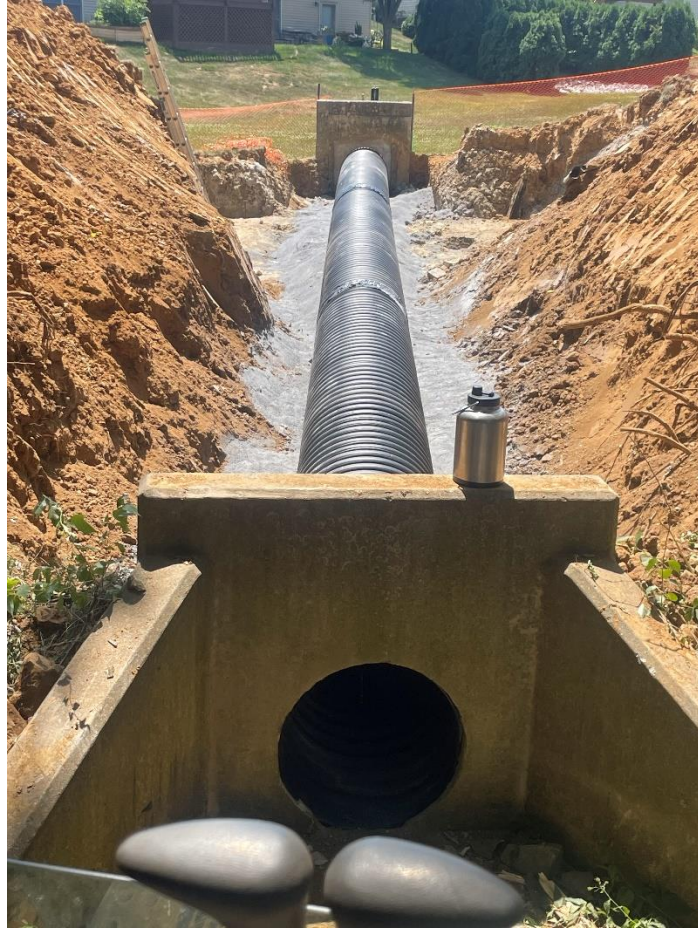
Photograph No. 17 – New 24-inch pipe after placement

On July 9, 2024, the Contractor placed approximately 60 feet of new 24-inch, N12 pipe (PVC) between the outlet structure and end wall. The pipe was bedded in about 6 to 12 inches of compacted modified 2A stone. Lime or stone dust was also applied over top of the aggregate. Small quantities of flowable fill were also placed along the pipe sidewall within the immediate AOC area that was excavated and backfilled on July 8, 2024. The additional flowable fill placement along the sidewalls was to provide for further reinforcement and stabilization.

The pipe placement included Mar-Mac water tight banding/seals at the joints. The slope of the new pipe was checked by the Contractor and deemed appropriate to provide adequate conveyance of stormwater from high to low elevations.

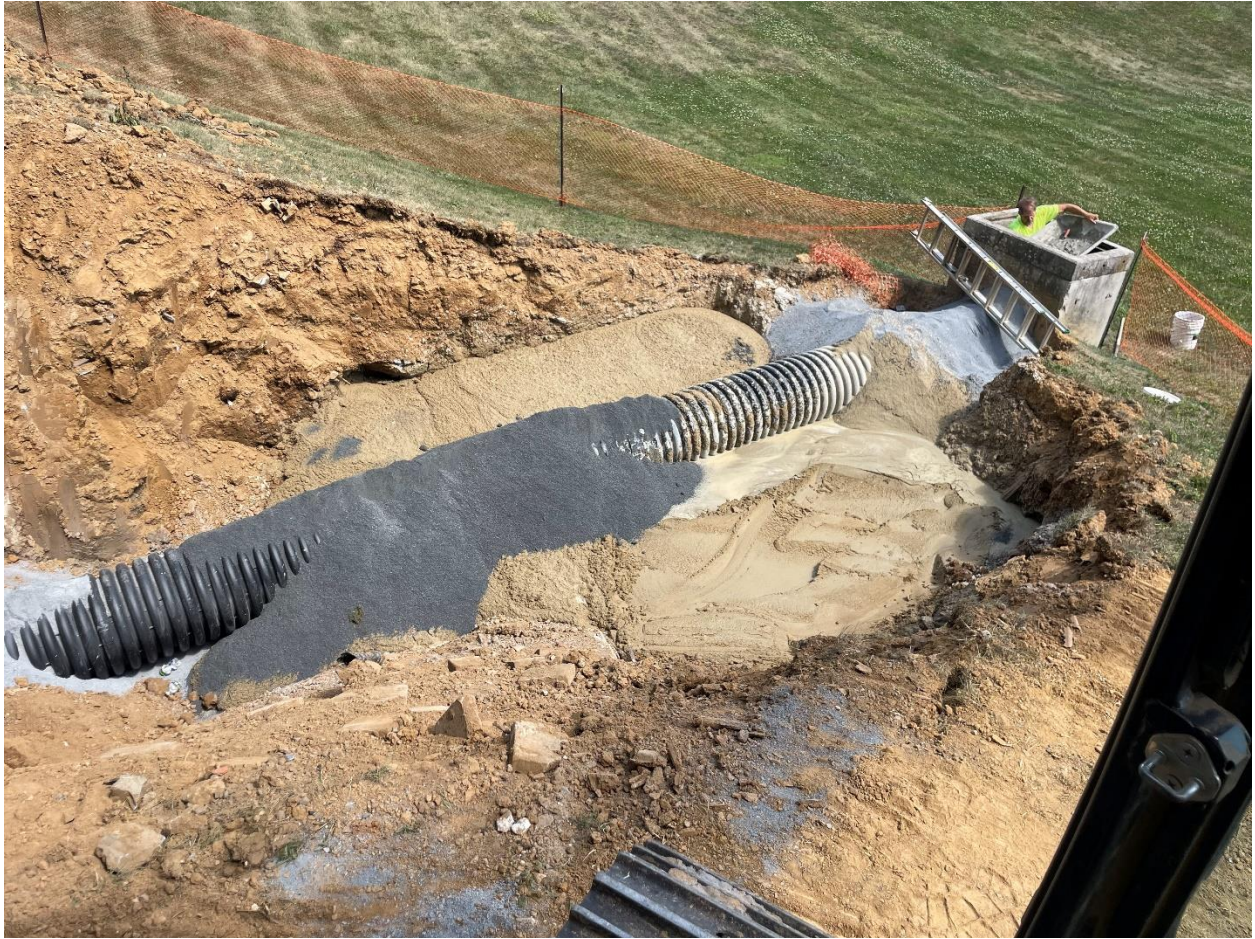
Photograph No. 18 – Additional flowable fill and backfilling placement around new pipe

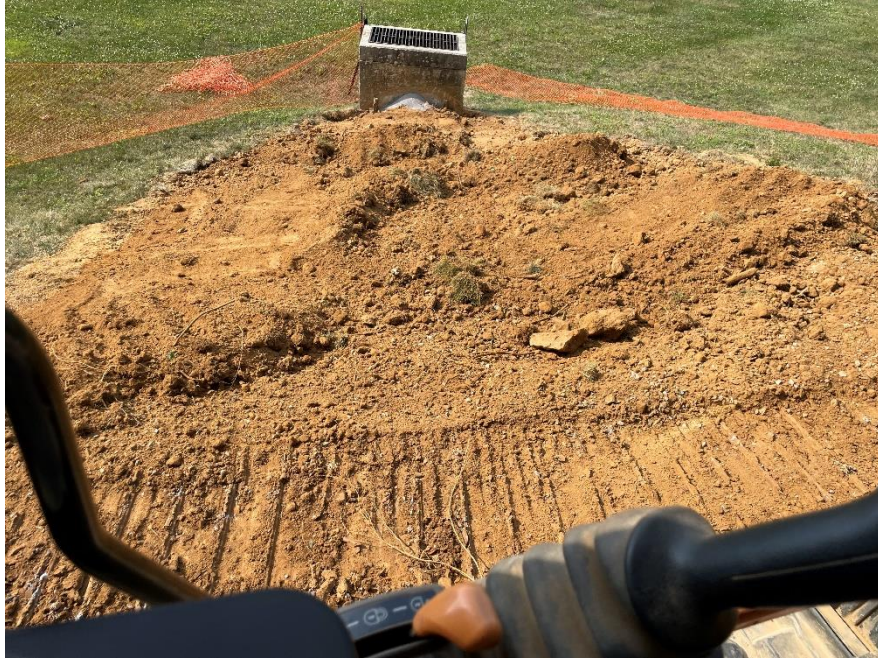
Photograph No. 19 – Grading/backfill activities near the outlet structure

On this date, the contractor backfilled the remaining portion of the excavation and pipe trench with soil backfill. Backfill placement was performed in lifts and compacted using the vibratory plate and the track-mounted excavation equipment.

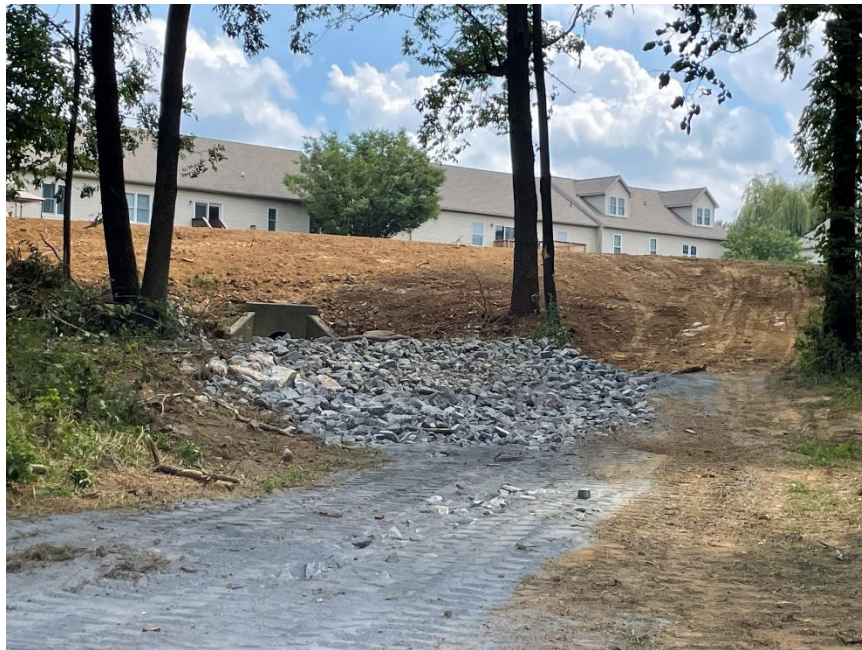
Photograph No. 20 – Completed backfilling/restoration at end wall on July 10, 2024

After completion of the backfill activities, the disturbed area was finished using a thin layer of topsoil, seeded and stabilized.

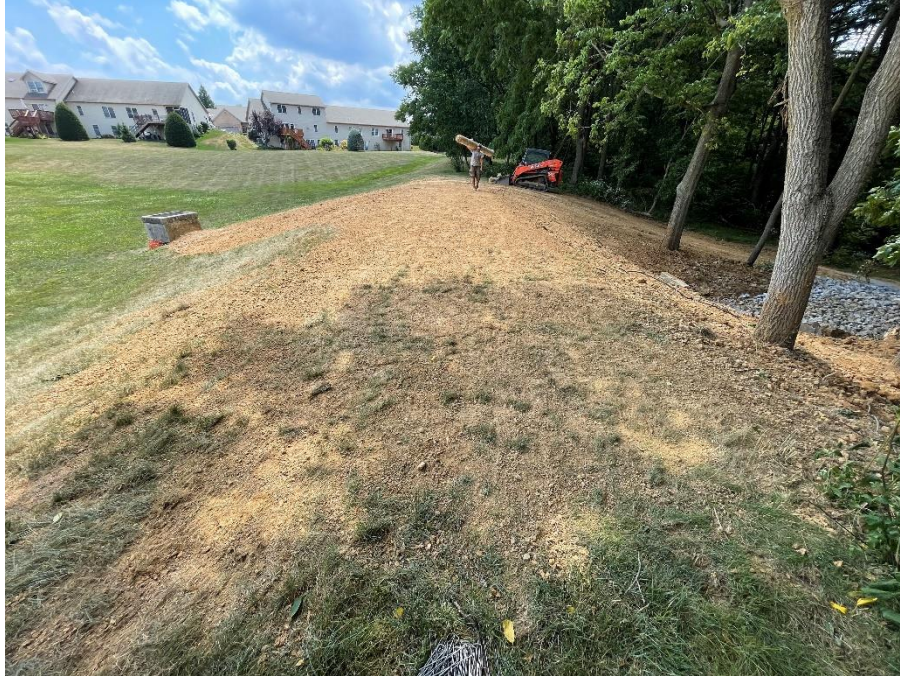
Photograph No. 21 – View of restoration across top of berm, facing west

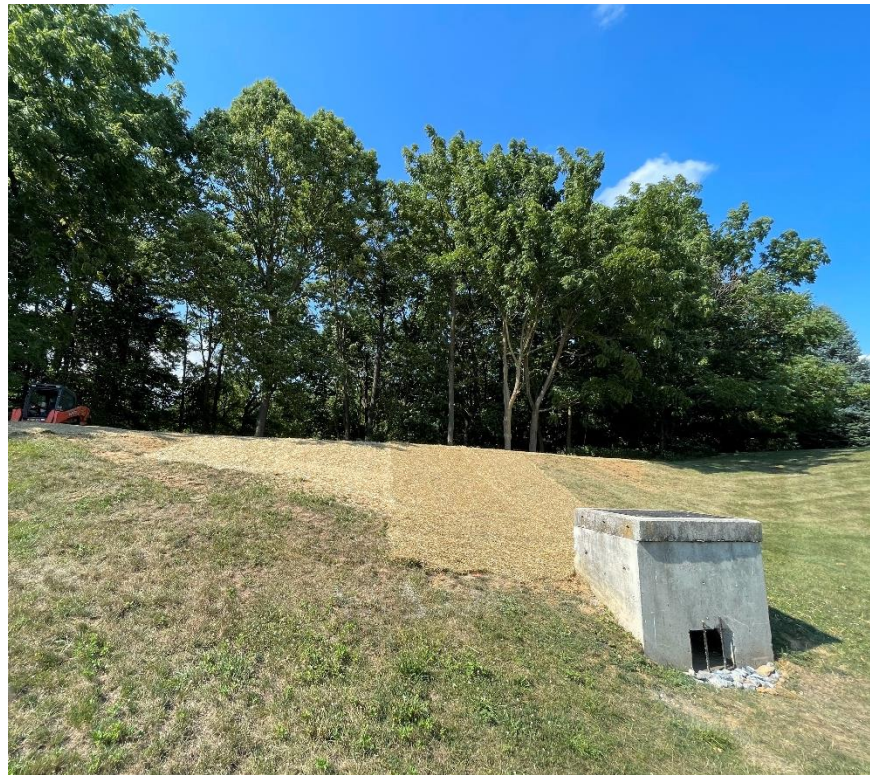
Photograph No. 22 – View from basin of restoration of ground surface facing north
